Field Report for Airborne Data Collected In Support of US EPA Region VI International Terminal Corporation Fire 17 March 2019

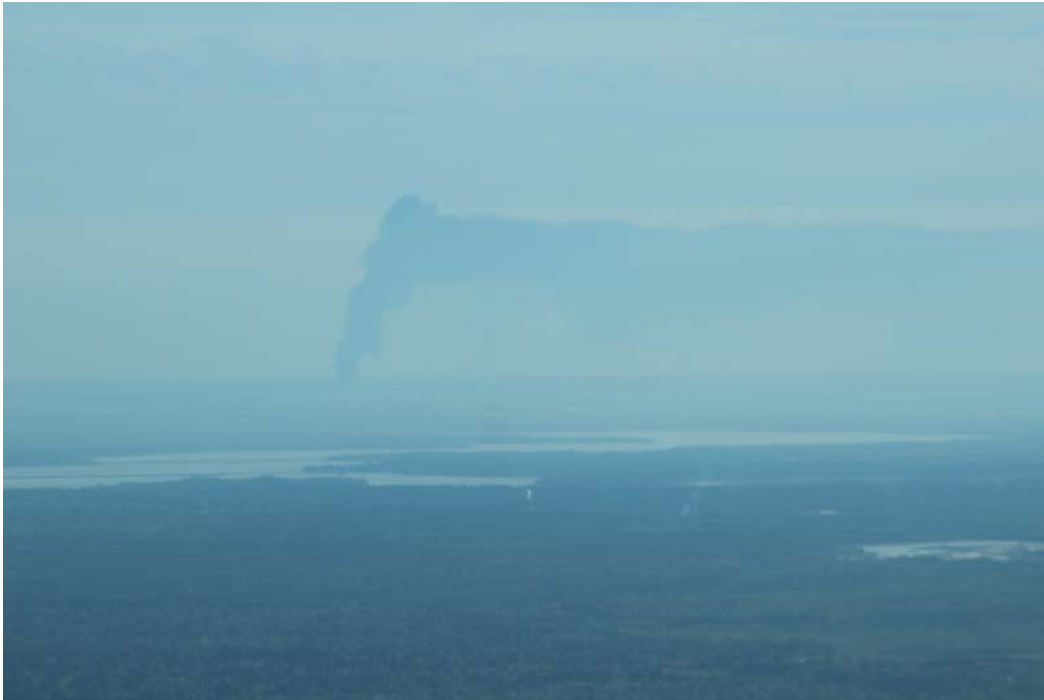
The crew reported that winds at altitude (2800 ft) are light and from the east. . Smoke emitted from the fire was reported to be gray in color and was visible 40 miles from the facility. It was reported that the plume was rising near vertical up to 4000 feet and then moving toward the west (figure 2). In general, the smoke was being pushed into a layer with the floor at 3500 and the top at about 4000 which appears to be a fairly strong thermal inversion.

Figure 2 : ITC Fire Plume, Approximately 40 miles away. Note vertical lofting of the plume.

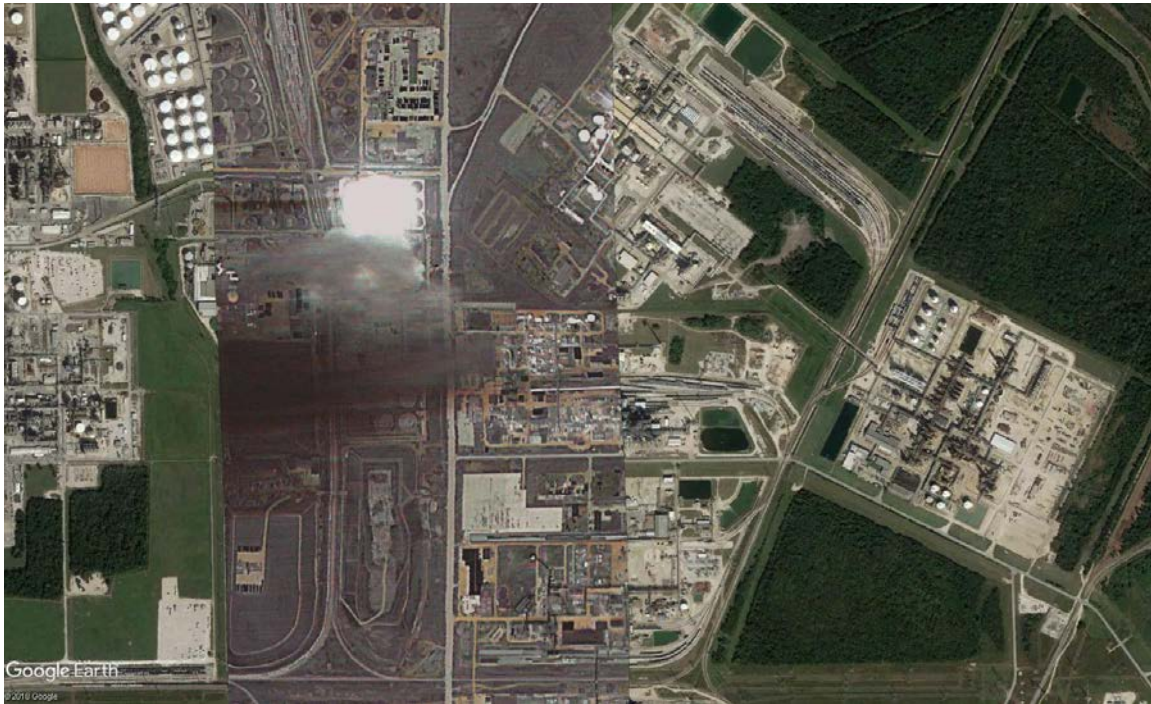
band infrared image obtained from data collected for Run 4. The white area within the image overlay is the thermal plume of the fire. Immediately south of the fire, a region of elevated temperature can be seen. This is most likely air being heated by the fire. Approximately 300 meters further south an area of obscuration of the surface (ground) thermal signature is present. This is likely the impact of volume and geometry of the plume block transmission due to the particulate load of the fire. It should be noted that no evidence of a chemical plume being generated by the fire was observed. A similar image generated on run 5 clearly shows an elevated temperature plume being generated by the fire (Figure 5).

Figure 4: – 3 band IR image, Run 4, International Terminal Corporation Fire

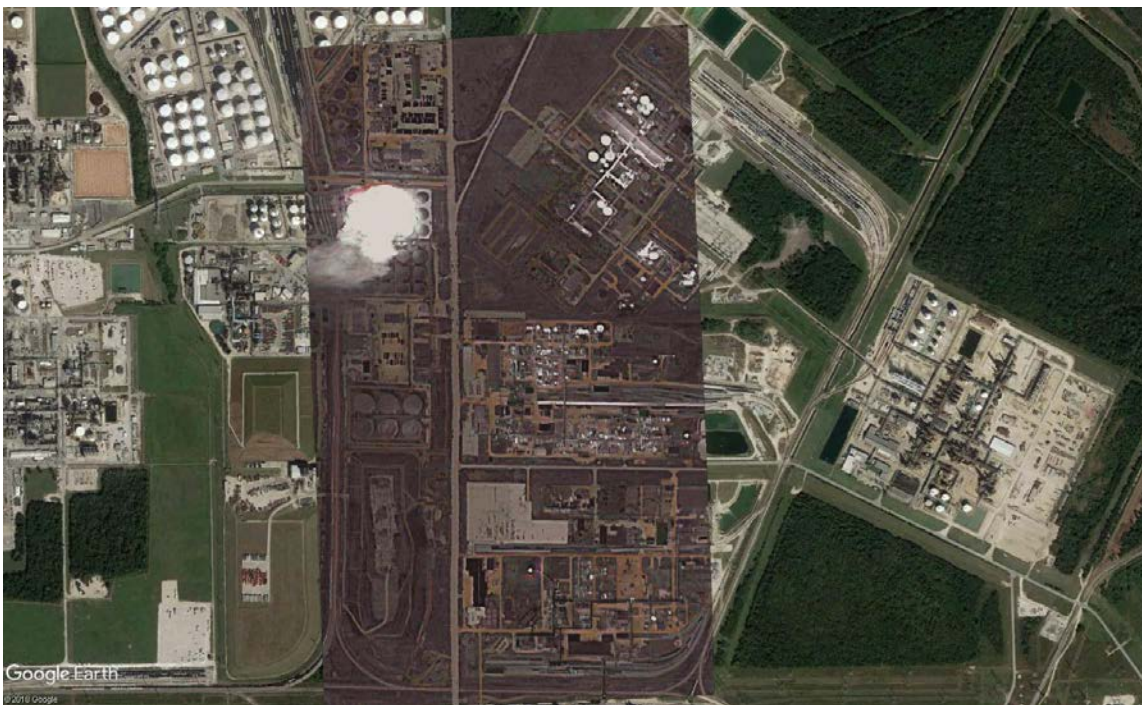
Figure 5: 3 band IR image, Run 5, International Terminal Corporation Fire

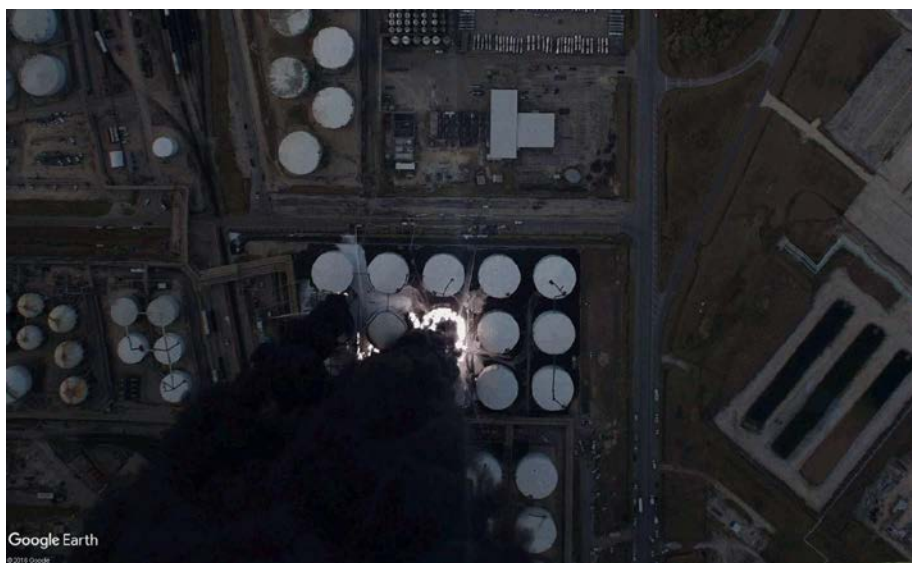
A full set of high resolution aerial digital photography were collected as part of the flight. Figure 7 shows a representative image collected as part of each pass. This image clearly shows the presence of fire in the center tank with additional fire surrounding the tank. The fire is generating a large amount of smoke which is rising nearly vertical. The low light conditions of the image are actually a result of the plume shading the area as the aircraft passed over the site.

Figure 7: Aerial Image of the International Terminal Corporation Fire.
